# DEALER SERVICE BULLETIN

Bulletin	87-5-13B
Date	Feb. '93
Ref. No.	87-240-5
Corp. Ref. No.	035002R

**SUBJECT: POWERMASTER BRAKES (DIAGNOSTIC INFORMATION/ INSTALL NEW KIT)**

**MODELS AFFECTED: 1986 LESABRE/ELECTRA ESTATE WAGON  
1985-87 REGAL WITH 3.8 S. F. ■. TURBO**

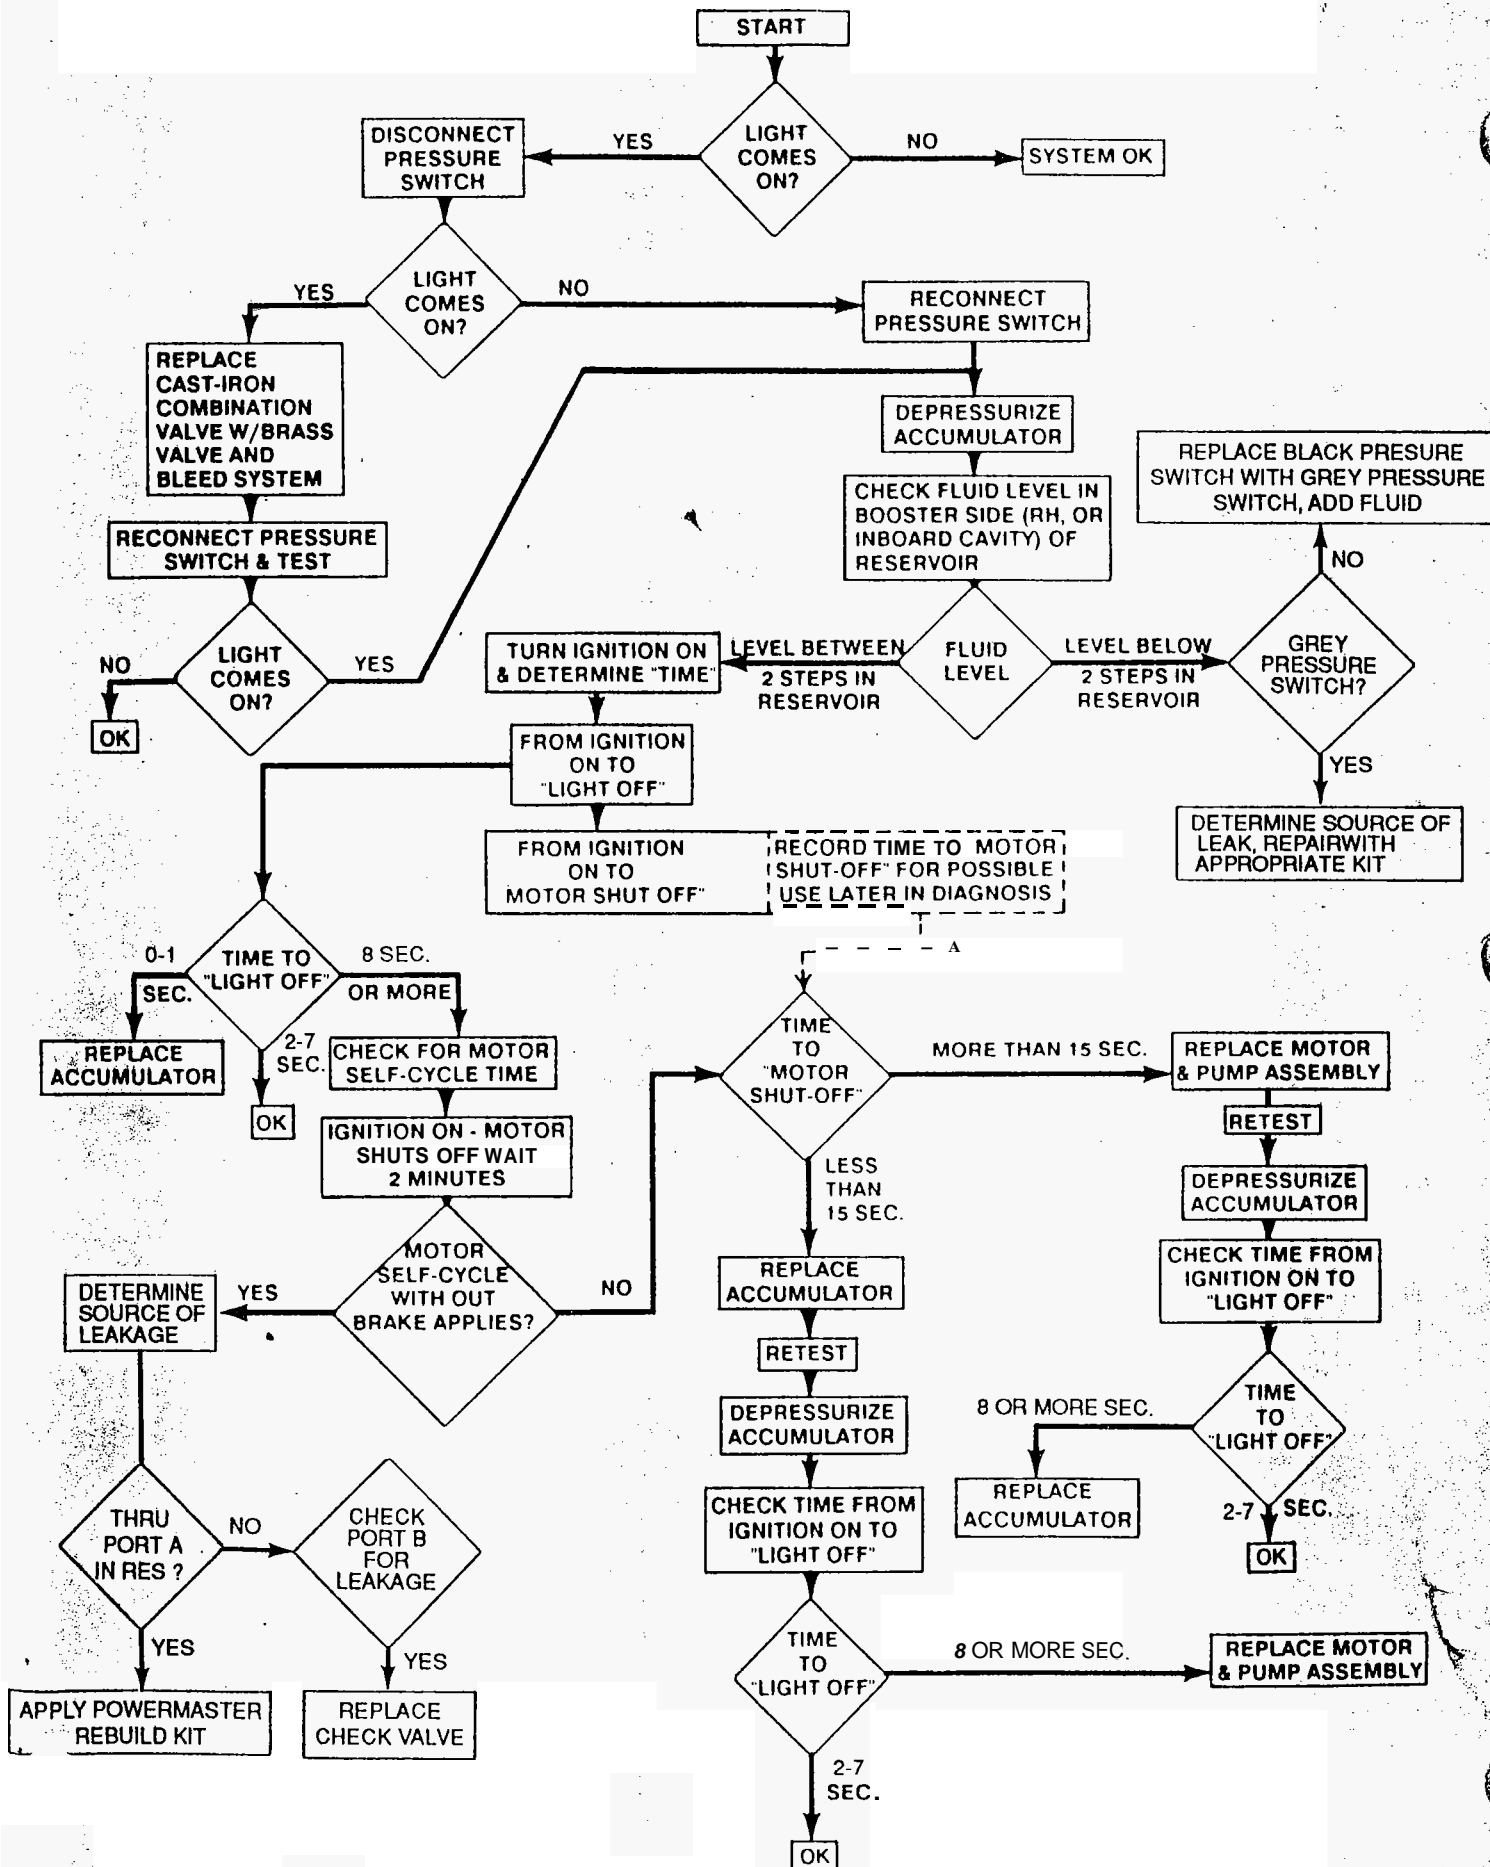
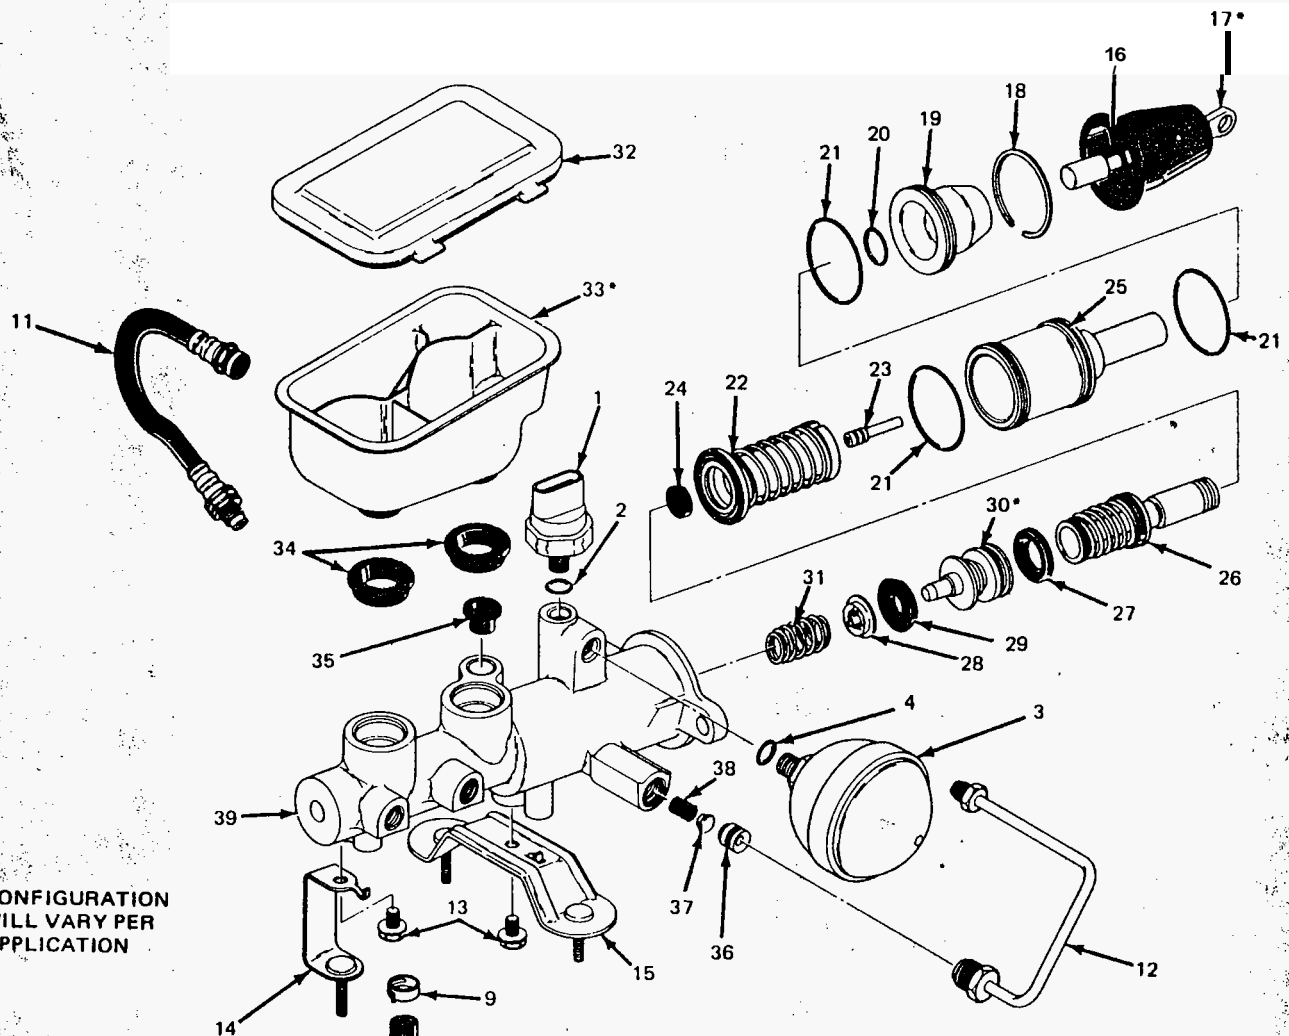
Figure 1

- 1. PRESSURE SWITCH
- 2. O-RING
- 3. ACCUMULATOR
- 4. O-RING
- 5. NUT
- 6. WASHER
- 7. GROMMET
- 8. E-H PUMP
- 9. HOSE CLAMP
- 10. SUMP HOSE
- 11. PRESSURE HOSE ASSEMBLY
- 12. TUBE & NUT ASSEMBLY
- 13. BOLT
- 14. BRACKET ASSEMBLY
- 15. BRACKET ASSEMBLY
- 16. RETAINER
- 17. BOOT, PUSHROD, SOCKET GROUP
- 18. RETAINER
- 19. PISTON GUIDE
- 20. O-RING
- 21. O-RING

- 22. REACTION BODY GROUP
- 23. REACTION PISTON
- 24. REACTION DISC
- 25. POWER PISTON ASSEMBLY
- 26. PRIMARY PISTON ASSEMBLY
- 27. SECONDARY SEAL
- 28. SPRING RETAINER
- 29. PRIMARY SEAL
- 30. SECONDARY PISTON
- 31. SPRING
- 32. RESERVOIR COVER AND DIAPHRAGM
- 33. RESERVOIR
- 34. RESERVOIR GROMMET
- 35. RESERVOIR GROMMET
- 36. VALVE SEAT AND SEAL
- 37. POPPET
- 38. SPRING
- 39. POWERMASTER BODY

- C. Clean and remove the reservoir cover.
- D. Disconnect the booster tube and nut assembly from the casting boss at the pump outlet located adjacent to the pressure switch assembly (Figure 1).

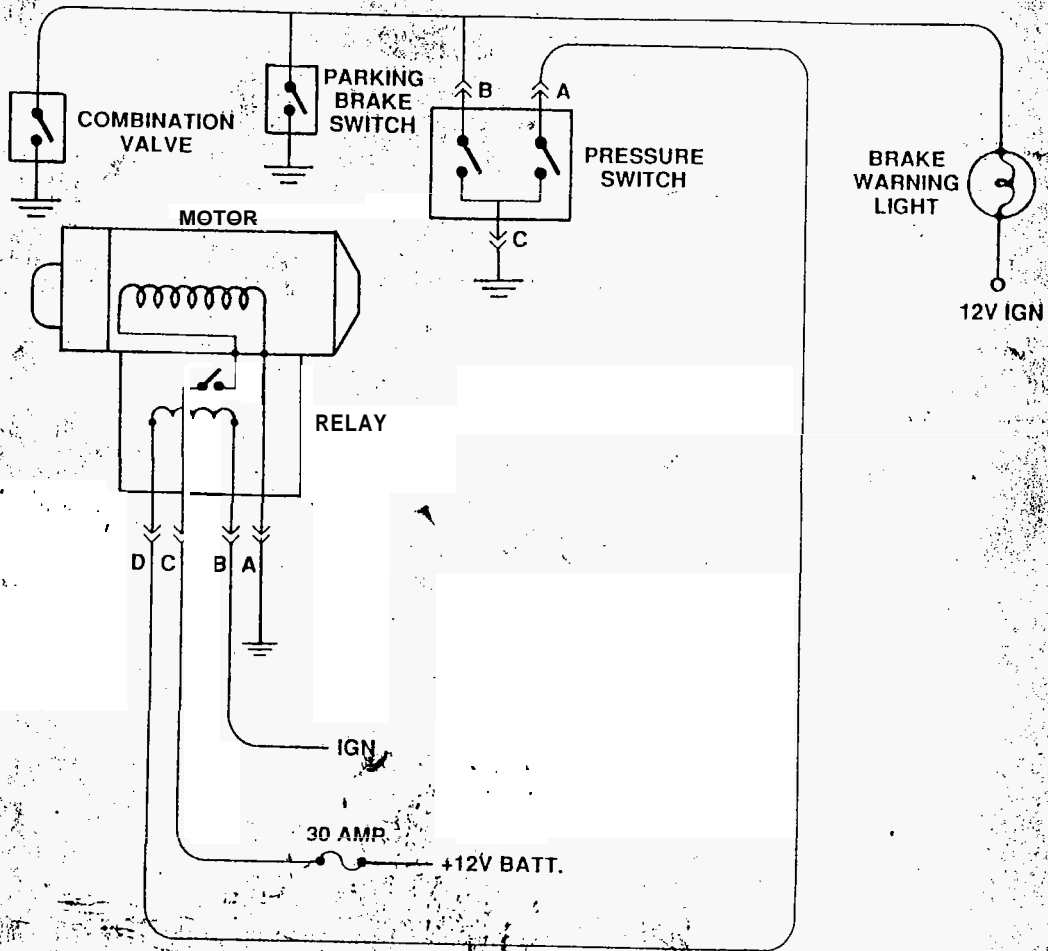
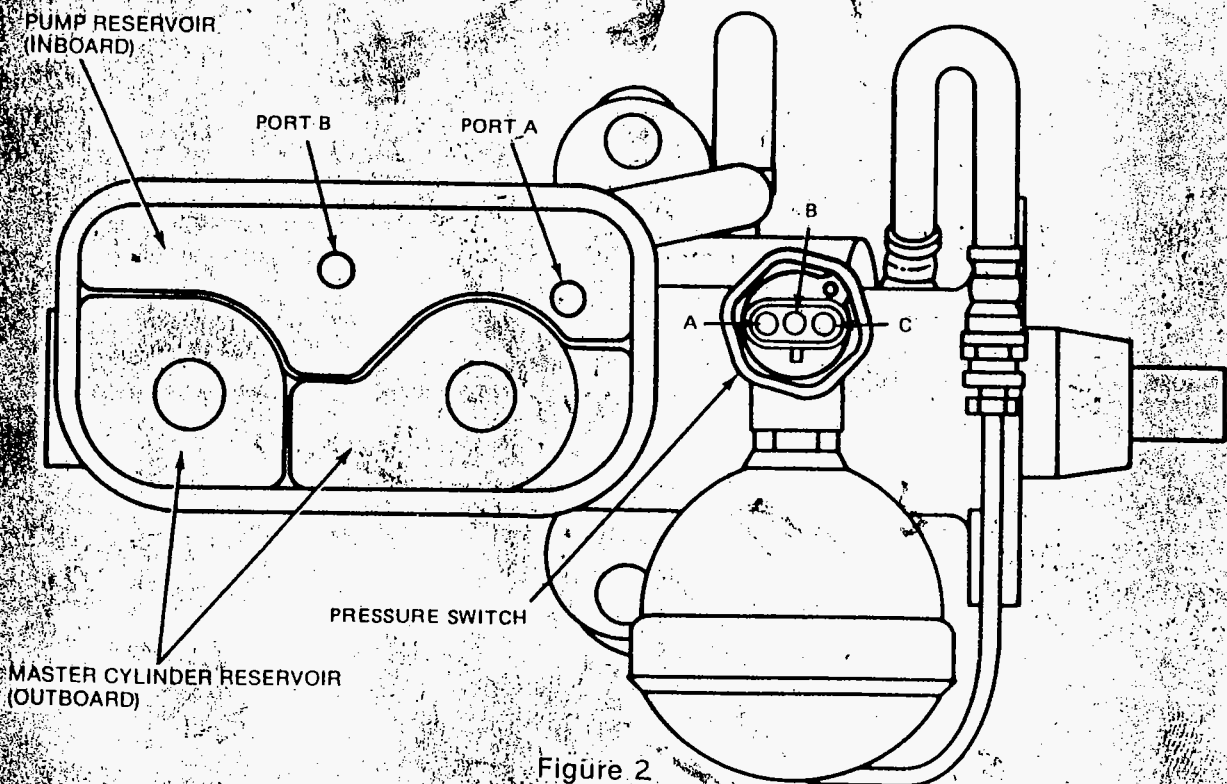
Figure 2

A. Make ten medium to high effort brake applies with ignition off to de-pressurize the system. Check fluid level in booster pump reservoir by observing if level falls between the two gage marks located on the inside of the pump reservoir (Figure 2).

1. Place a short piece (6-12 inches) of flexible plastic tubing (approximately 1/4 inch-1/2 inch diameter) over Port A in the inboard pump reservoir (Figure 2). **If** leakage is occurring, fluid will rise in the tube. Repair this fault with Seal Repair Kit 18020067. **If** no leakage is found, examine Port B.

2. Place the same plastic tubing over Port B (Figure 2). **If** leakage is observed here, repair with Check Valve Repair Kit 18018552.
- C. De-pressurize the system with ten brake applies and ignition off. Fluid level must be within gage marks in reservoir.

Repair leak or replace leaking part. Add fluid, to master cylinder reservoir per Figure 2.
