# DEALER SERVICE BULLETIN

Bulletin	87-5-13B
Date	Feb. '93
Ref. No.	87-240-5
Corp. Ref. No.	035002R

**SUBJECT: POWERMASTER BRAKES (DIAGNOSTIC INFORMATION/INSTALL NEW KIT)**

**MODELS AFFECTED: 1986 LESABRE/ELECTRA ESTATE WAGON  
1985-87 REGAL WITH 3.8 S.F.I. TURBO**

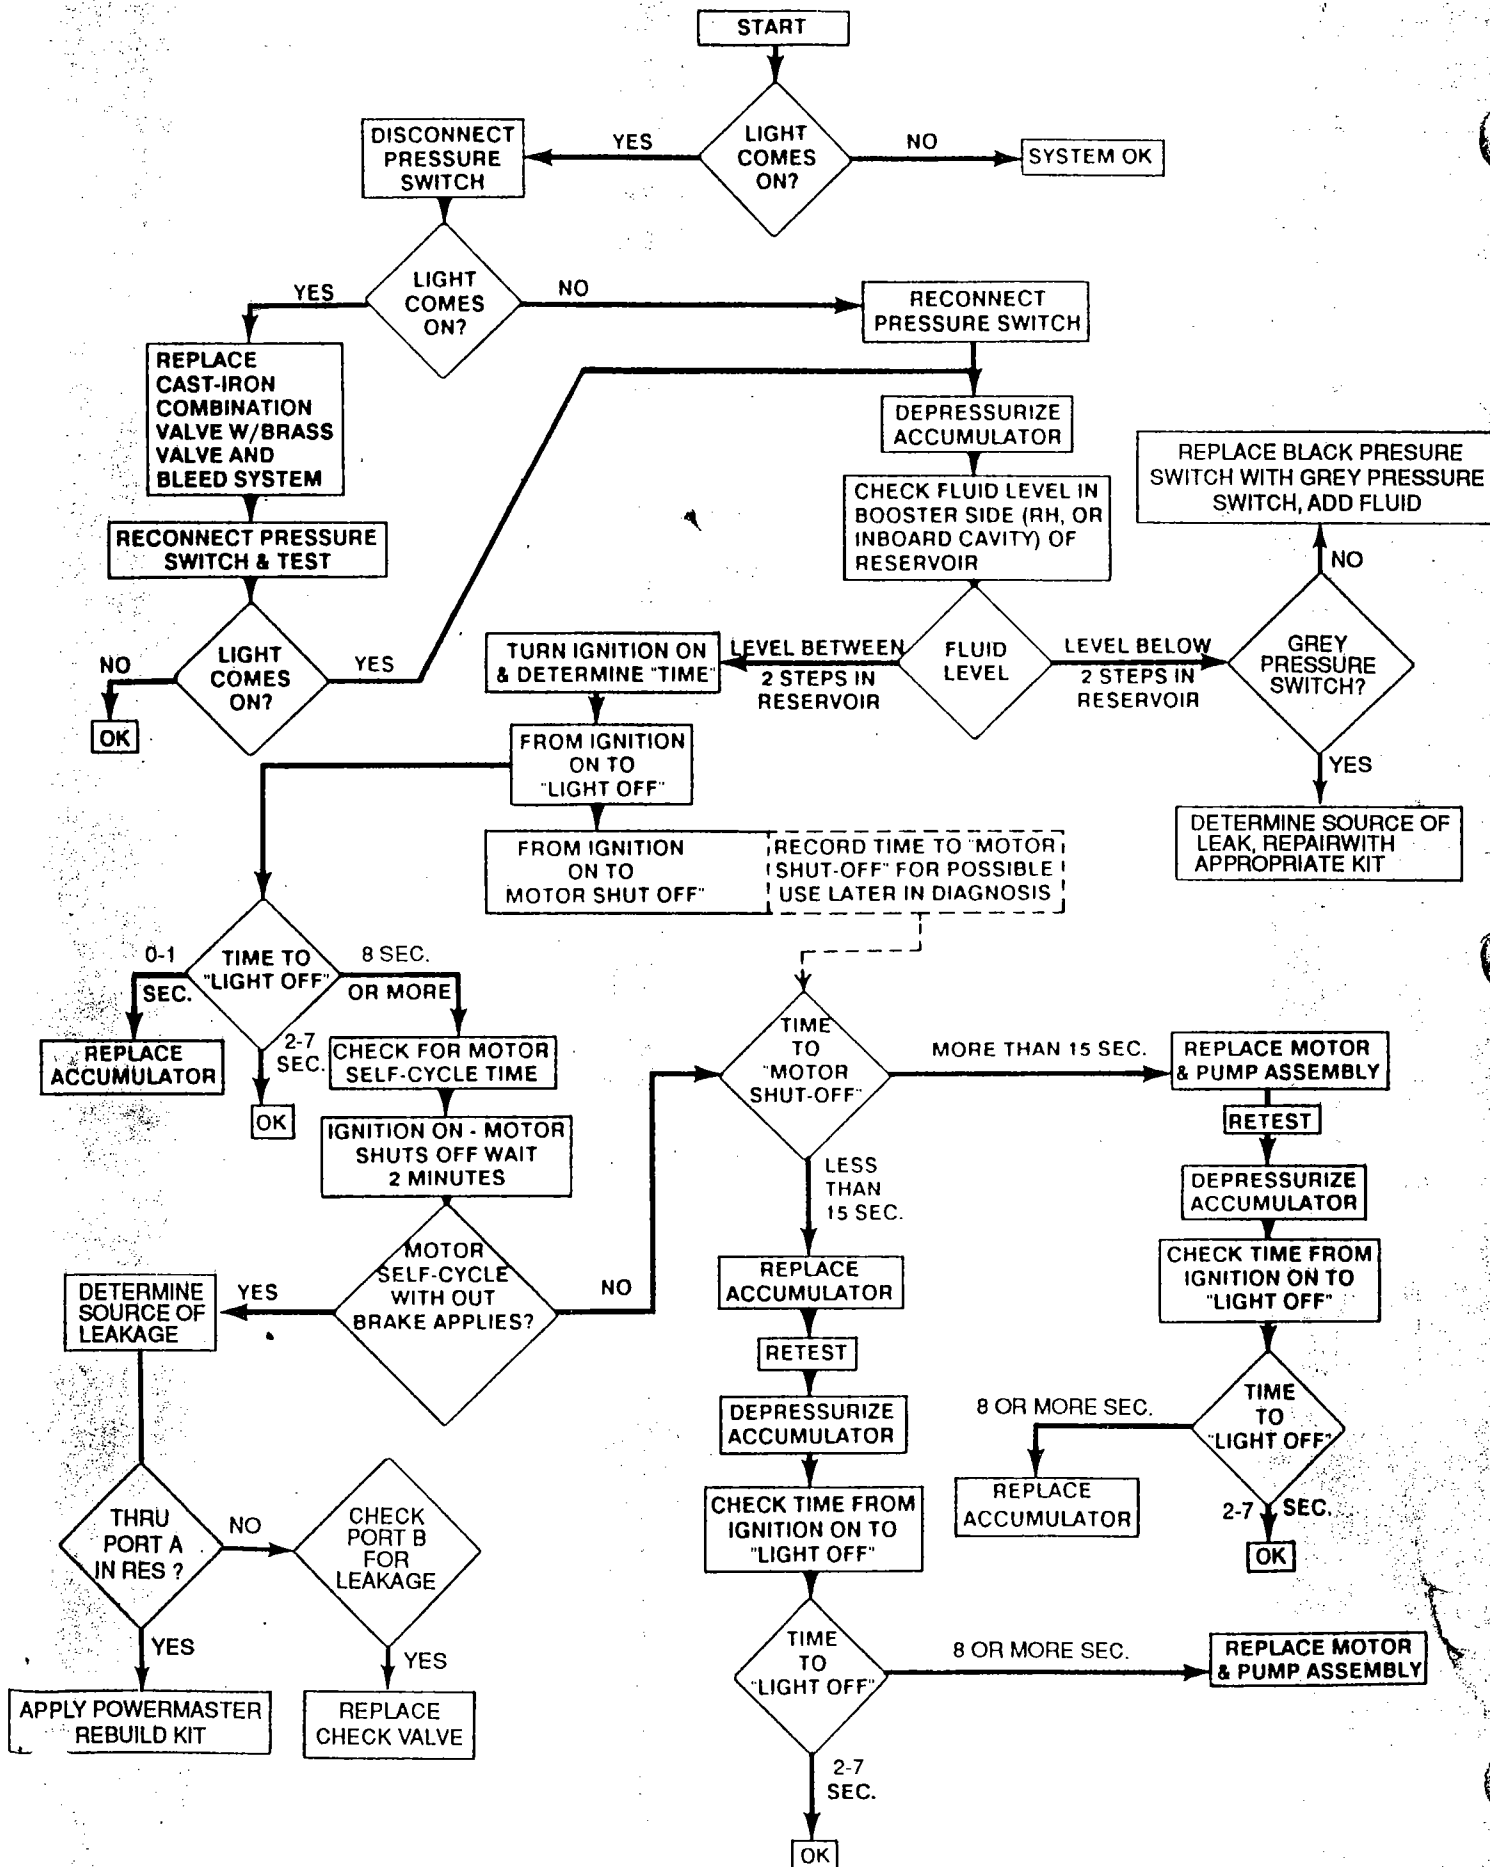
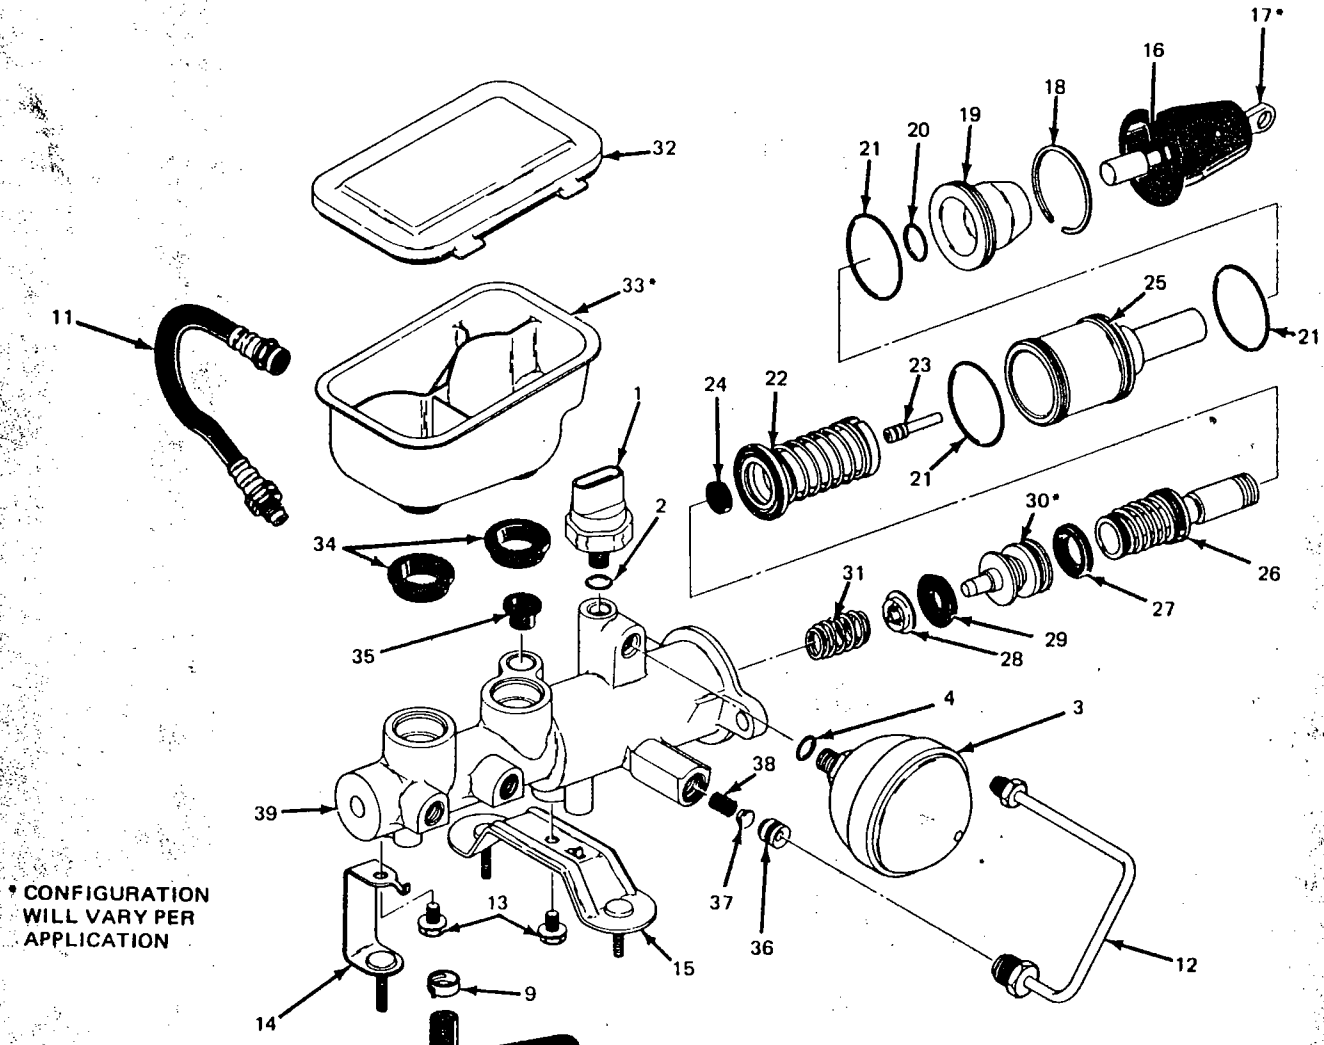
Figure 1

- C. Clean and remove the reservoir cover.
- D. Disconnect the booster tube and nut assembly from the casting boss at the pump outlet located adjacent to the pressure switch assembly (Figure 1).

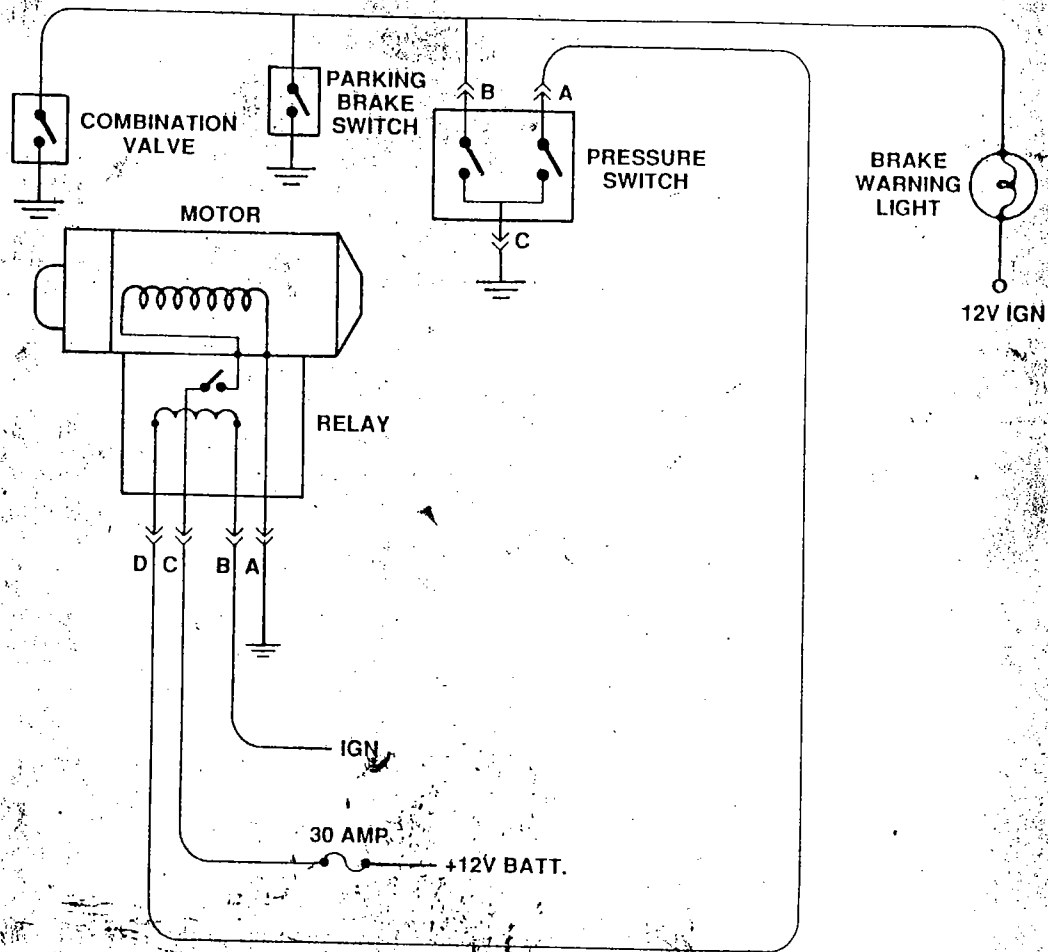
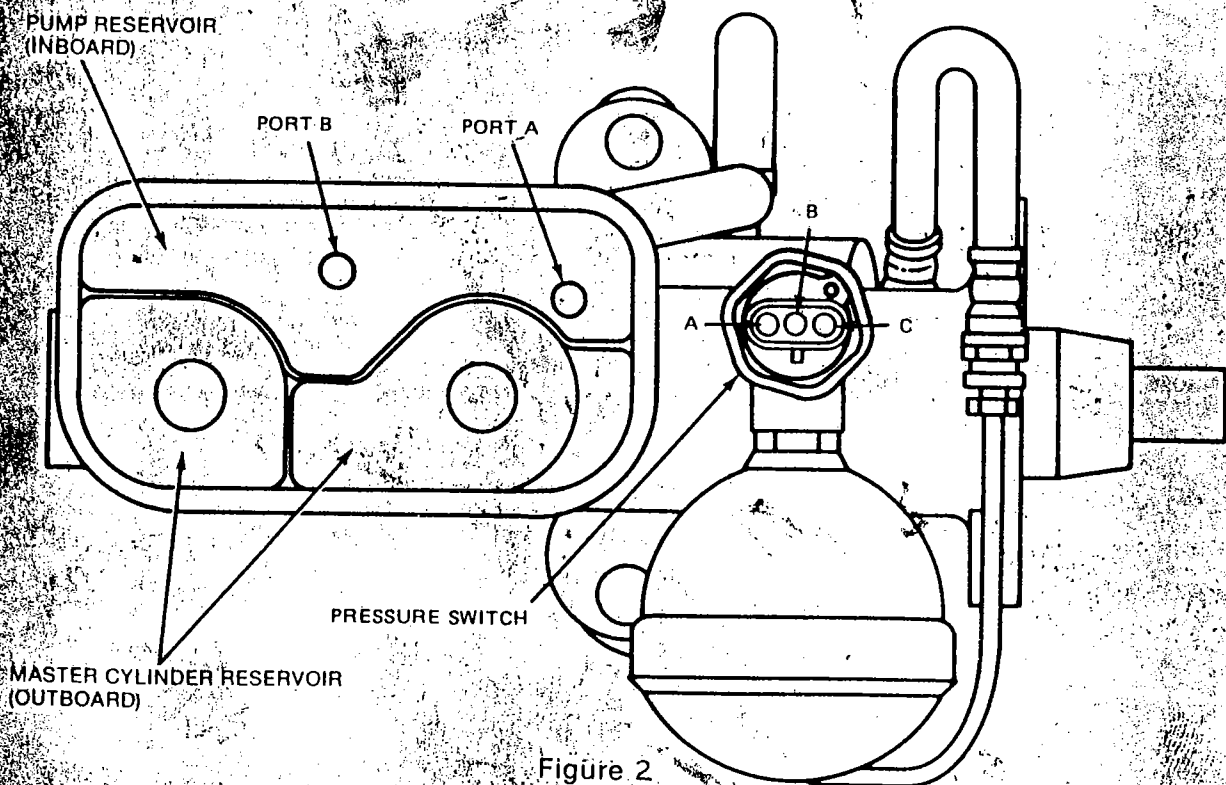
Figure 2

1. Place a short piece (6-12 inches) of flexible plastic tubing (approximately 1/4 inch-1/2 inch diameter) over Port A in the inboard pump reservoir (Figure 2). If leakage is occurring, fluid will rise in the tube. Repair this fault with Seal Repair Kit 18020067. If no leakage is found, examine Port B.

2. Place the same plastic tubing over Port B (Figure 2). If leakage is observed here, repair with Check Valve Repair Kit 18018552.
- C. De-pressurize the system with ten brake applies and ignition off. Fluid level must be within gage marks in reservoir.

- A. Make ten medium to high effort brake applies with ignition off to de-pressurize the system. Check fluid level in booster pump reservoir by observing if level falls between the two gage marks located on the inside of the pump reservoir (Figure 2).
